Scenic Rim Flood Modelling

Canungra Creek and Biddaddaba Creek Flood Study Report

Scenic Rim Regional Council

Reference: 502966 Revision: 1 2019-06-17

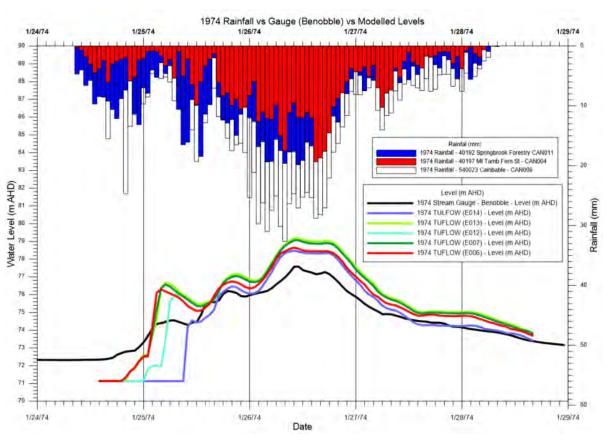
Figure 1 Main Road Bridge (Benobble) water level comparison 1974 event

Figure 1 presents the peak water levels at the Benobble stream gauge for each of the model runs and the stream gauge for the 1974 event.

Comparison between the rainfall patterns and time to peak for recorded and modelled levels for the 1974 event appear to be reasonable, meaning that the rainfall is a reasonable representation of the pattern of rain that fell on the catchment.

Overall, the hydraulic model results appear to be consistently higher than the observed gauge readings (refer Table 10) and changing both the roughness and loss rates has a limited impact on results.

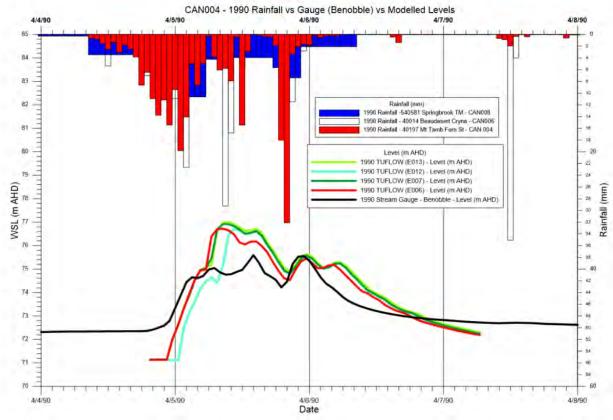
Figure 2 Main Road Bridge (Benobble) water level comparison 1990 event

Figure 2 presents the peak water levels at the Benobble stream gauge for each of the model runs and the stream gauge for the 1990 event.

Comparison between the rainfall patterns and time to peak for recorded and modelled levels for the 1990 event shows that the rainfall is potentially not representative of what actually fell in the catchment. There are three rainfall datasets used and each vary in distribution and where the peak rainfall occurs. Therefore, matching the peak levels recorded by the stream gauge is challenging.

Overall, the hydraulic model results appear to be consistently higher than the observed gauge readings (refer Table 10) and changing both the roughness and loss rates has a limited impact on results.

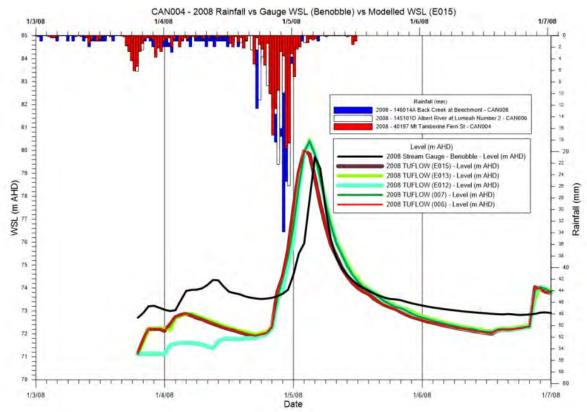
Figure 3 Main Road Bridge (Benobble) water level comparison 2008 event

Figure 3 presents the peak water levels at the Benobble stream gauge for each of the model runs and the stream gauge for the 2008 event.

Comparison between the rainfall patterns and time to peak for recorded and modelled levels for the 2008 event show a slight difference in the time of the peak. There are no rainfall stations within the actual catchment and rainfall data from surrounding catchments is being applied. This influences the shape and timing of the model results however a reasonable representation of the hydrograph shape is achieved.

Of the calibration events modelled, the 2008 event has achieved the best peak flood level match (refer Table 11) at the Benobble stream gauge, where the modelled flood depth was within 5% of the recorded depth. Similarly, for many of the historical flood level markers along the watercourse, the hydraulic model achieved a match to within 5% of the recorded flood depths. Refer to Attachment A for a long section and Attachment B in Appendix B for a tabulated comparison of 2008 event modelled peak flood levels against historical flood marker levels.

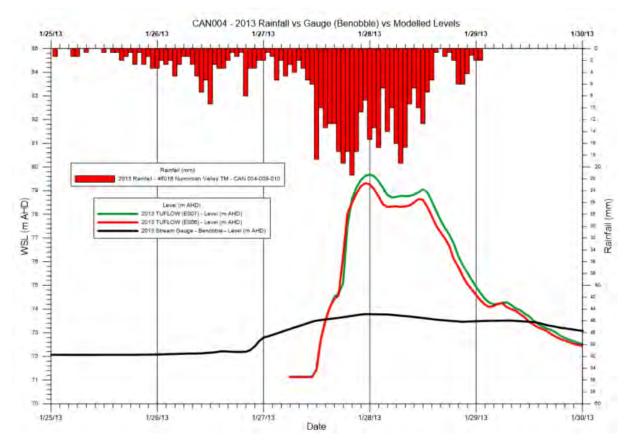
Figure 4 Main Road Bridge (Benobble) water level comparison 2013 event

Figure 4 presents the peak water levels at the Benobble stream gauge for each of the model runs and the stream gauge for the 2013 event.

Review of the rainfall and recorded stream gauge data, as well as the hydraulic model results, shows that is it likely that the stream gauge failed during the 2013 event. Therefore the 2013 event has not been considered in this instance for testing the performance of the hydraulic model. Sufficient doubt over the quality of the gauge readings exists for the following reasons:

- The magnitude of rainfall observed in rainfall gauges around the catchment, and hence volume of runoff through modelling is comparable to the 1990 event and the predicted model flows in the 1990 event match the stream gauge data for that event reasonably well.
- The observed 2013 event peak levels for the next downstream gauge (Bromfleet stream gauge) on the Albert River support the prediction of larger flows through the Canungra catchment.

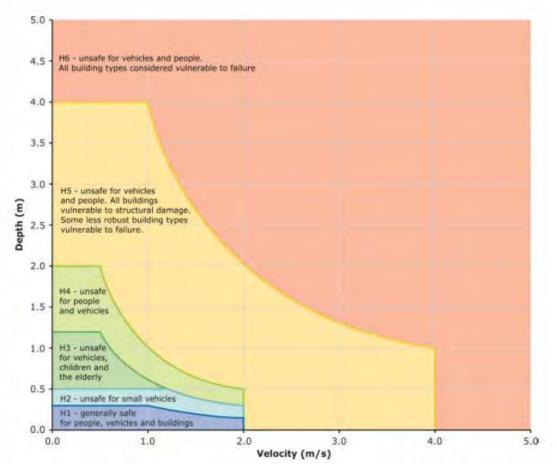
Figure 5 EMA revised flood hazard classification. Source: Australian Emergency Management Handbook Series (2013) - Technical flood risk management guideline: Flood hazard

- Peak velocities these maps present peak velocity contours in 0.5 m bands up to a velocity of 5 m/s
- Hazard maps Revised guidelines for presentation of flood mapping are now provided in the Australian Emergency Management Handbook Series (2013) produced by Emergency Management Australia (EMA). This handbook and its supporting flood risk management guidelines are intended to replace the SCARM guidelines under which the previous mapping was prepared. The revised guidelines include a revised categorisation for flood hazard which is shown below in Figure 4. The hazard maps have used a simplified version of this classification, where only 3 levels are outlined (Low, Medium and High Hazard). Each of these simplified bands represent 2 bands within the EMA classification.
